AIR-RAID SHELTERS ROUTE

The terrible bombing raids suffered by the Basque Country from 22 July 1936 onwards led the Basque government to decree that air raid shelters be built in all towns, regardless of whether they were of any strategic or military value. The Mayor of Gernika instructed municipal architect Castor Uriarte to have at least six shelters built for public use. At the same time, a large number of private shelters were also constructed.

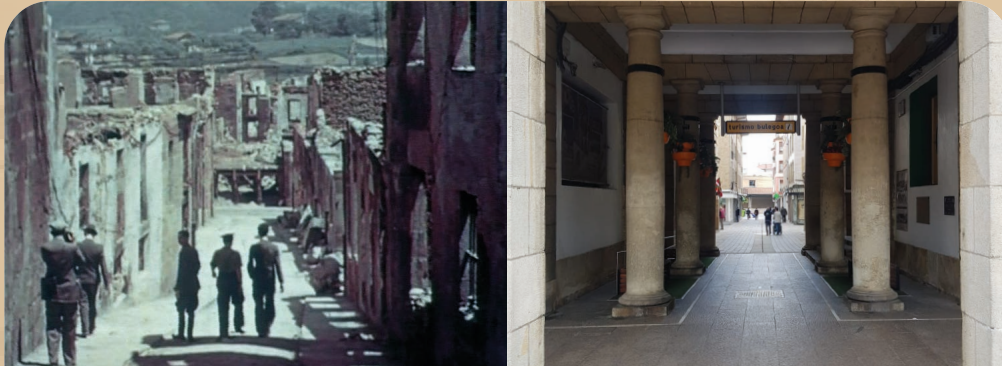
Andra Maria street air-raid shelter

The biggest shelter of all was on Calle Andra Maria, where the tourist information office now stands. Measuring 146 m², it extended all along the street and was made of thick wooden beams roofed with sandbags. The plan was to reinforce the roof with steel sheets, but they did not arrive in time. It was hit by one block-buster bomb and totally destroyed. It was built to hold 450 people and was full to capacity at the time of the bombing.

- The shelter on Calle Andra Maria, which suffered a direct hit from a 250 kg bomb, collapsed killing most of the people in it instantly.
- A large-calibre bomb also hit the town hall, bringing down the building on top of the bomb shelter in the basement. The entrance was blocked for around four hours and several people were injured by fragments of masonry brought down from the ceiling by the explosion. But rapid action by rescue teams enabled a tunnel to be opened up and most people were brought out alive.

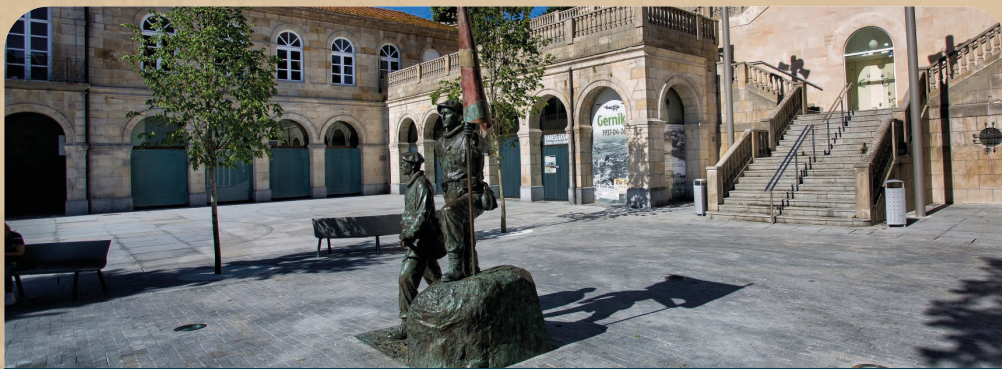
Pasealekua air raid shelter old entrance

'The safer shelters were on the west side of the Unión Square. The wall on this side rests against the mountain slope. We just dug four cave-shaped shelters into the mountain slope. They were about 10 metres deep. These four shelters were for the people from the market area and from the Feriál'. Castor Uriarte, municipal architect (1937)
Two of the four tunnels dug in 1936 were reopened in 2018. The smaller of them, which was never finished, now contains a scale model of the shelter as initially built. In the other you can see an audiovisual presentation with light and sound effects showing what it was like for those who sheltered here during the raid.

- A powerful bomb exploded on the street that ran above the shelter at Plaza de la Unión (now called Pasealeku Plaza), shattering the water main so that water leaked into part of the shelter below the point of impact. But this shelter,

which was several metres below ground level, held fast and those within it survived.

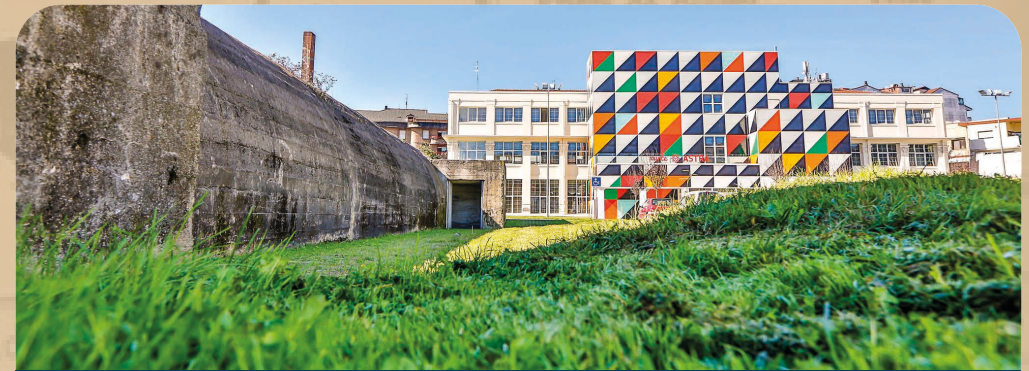
The former Astra armaments factory air raid shelter

The Talleres de Guernica (TdeG) factory built two shelters for its workers in September 1936:

- The first is now known as the "Astra" shelter. It takes its name from the renowned Astra 400 "la Puro" handgun, which was manufactured in Gernika in the first half of the 20th century.
- The second shelter is 22 m long and 5 m wide, and built with solid, 1 m thick walls.

The Astra shelter was built in September 1936 to house workers at Talleres de Guernica and other local factories.

It was restored and opened to the public when the old Astra Unceta y Cía workshop was demolished in 2005. It was built of concrete and camouflaged under a false roof so that it could not be identified as a bomb shelter from the air.

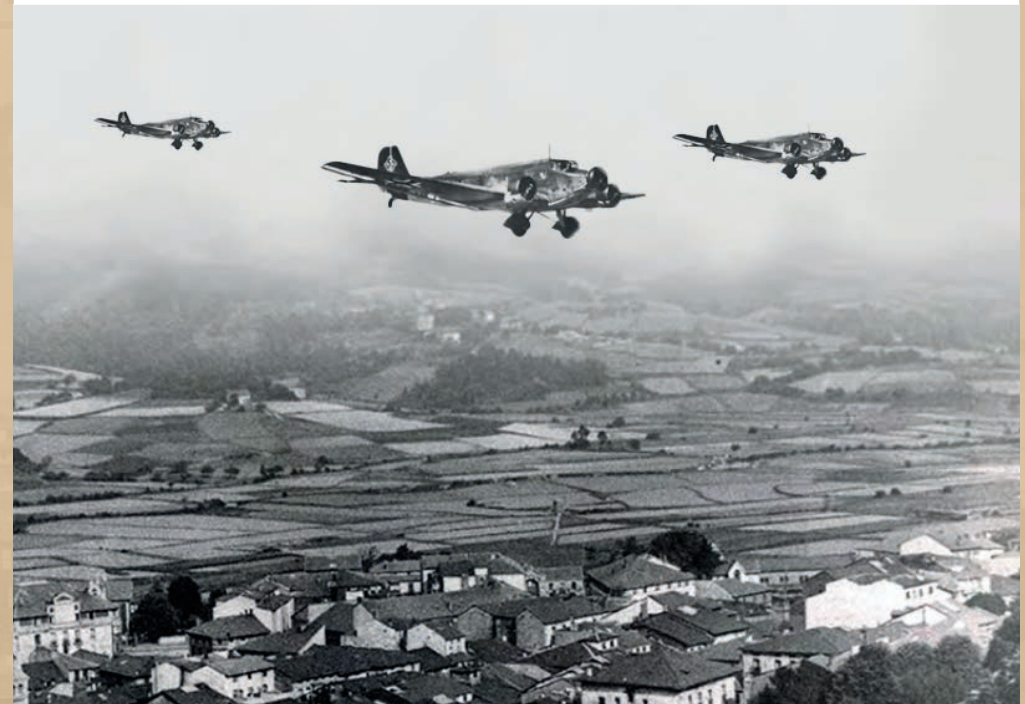
Recreation of Junkers Ju 52 planes flying on Gernika in formation

They included Junkers Ju 52, Heinkel He 111, Dornier Do 17 and Savoia-Marchetti SM 79 bombers accompanied by Heinkel He 51, Messerschmitt BF 109 and Fiat C.R.32 fighters and ground attack planes. Aircraft belonging to the Northern Air Force based in Lasarte also took part, taking aerial photographs of Gernika.

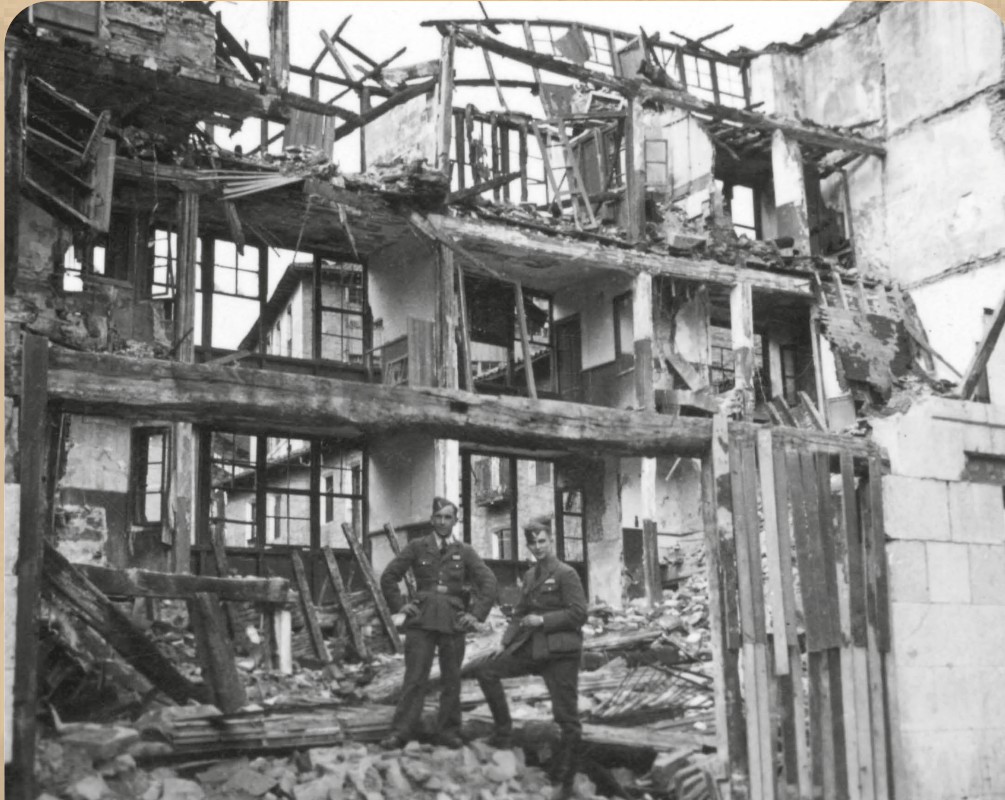
German soldiers checking the ruins of Gernika after the bombing

But it was in Gernika that the destruction reached its peak. Richthofen honed his bombing technique by launching a mixture of 250 kg explosive bombs and 1 kg incendiary devices (accounting for 65-85% of the total) from a height of 800 m.

The buildings hit by the 250 kg bombs collapsed completely and the rest were burned down by the incendiary bombs. **85,22% of all the buildings were destroyed.** The Basque Government registered 1,654 deaths. In addition, Mayor Jose Labauria recorded that 450 people lost their lives in the Andra Maria shelter.
